**Re: Enviro-Chem Superfund Site
Monthly Construction Progress Report Number 4
March 1998**

Attachment 1
Site Photographs

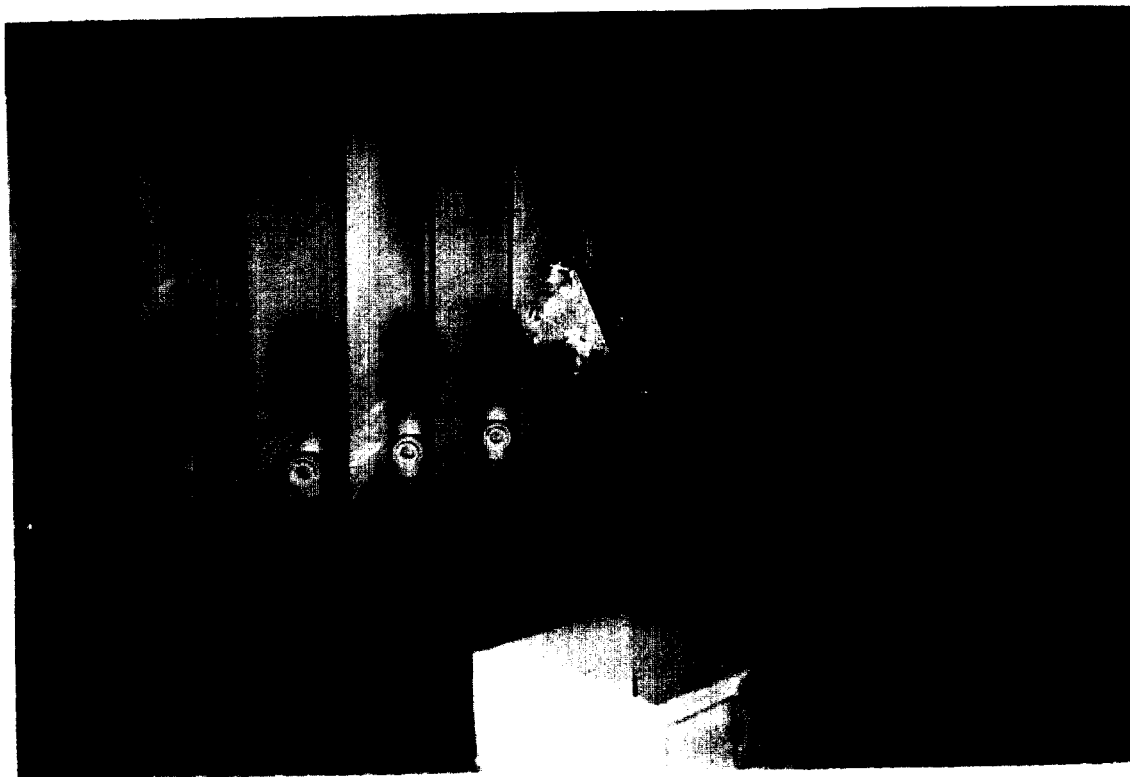
Photograph # 6 - View showing the beginning stages of fabrication of the SVE piping manifold.

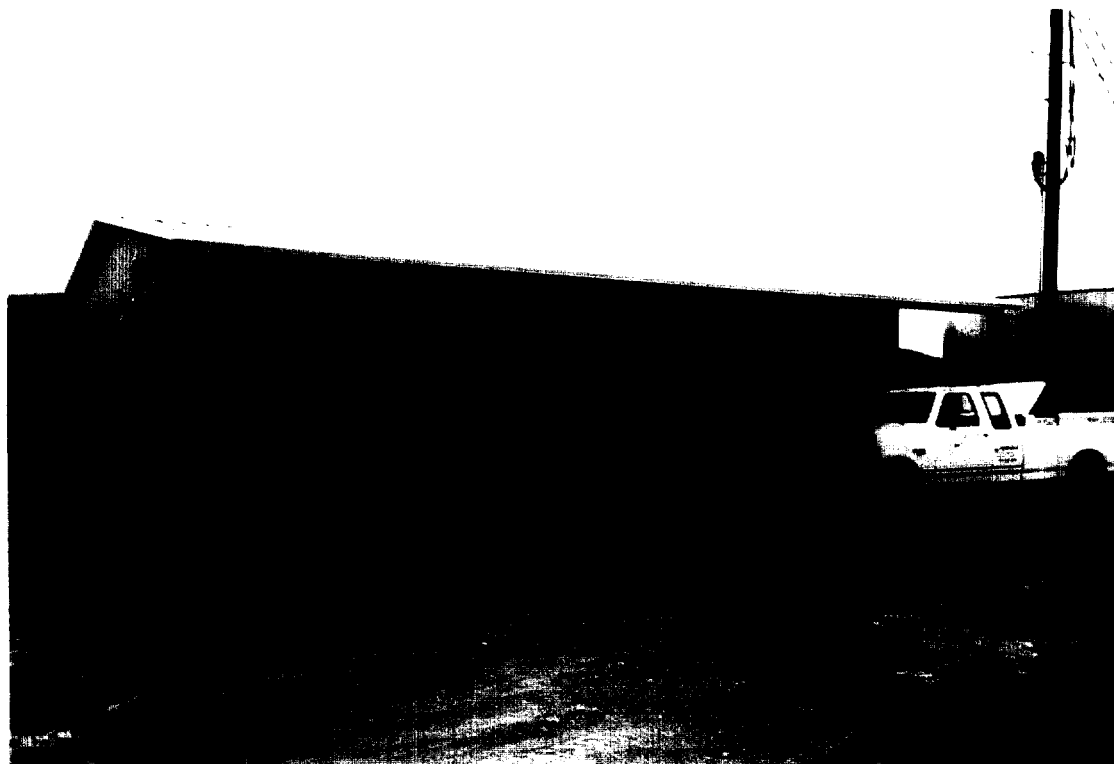
Photograph # 7 - View showing the placement of the two 13,000 pound activated carbon canisters.
